SALEM, NEW HAMPSHIRE

**WHEELER DAM
ARLINGTON MILL RESERVOIR
NH 00028**

**PHASE I INSPECTION REPORT
NATIONAL DAM INSPECTION PROGRAM**

AUGUST 1978

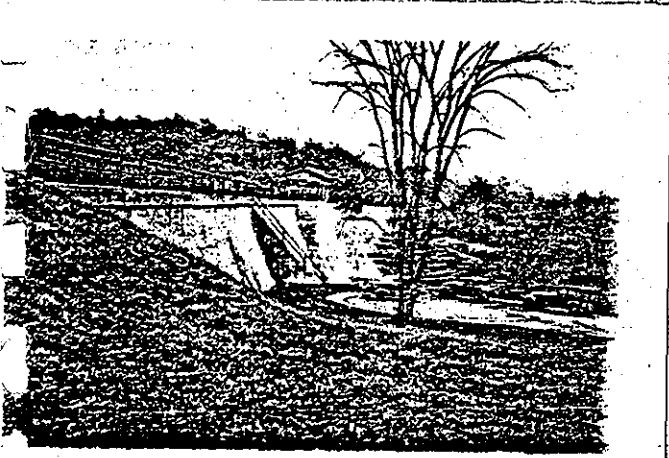
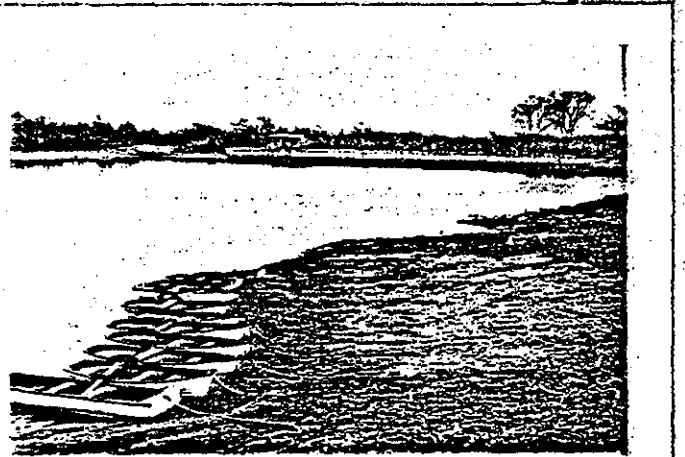
NOTE SPALLING AFTER
13 YEARS

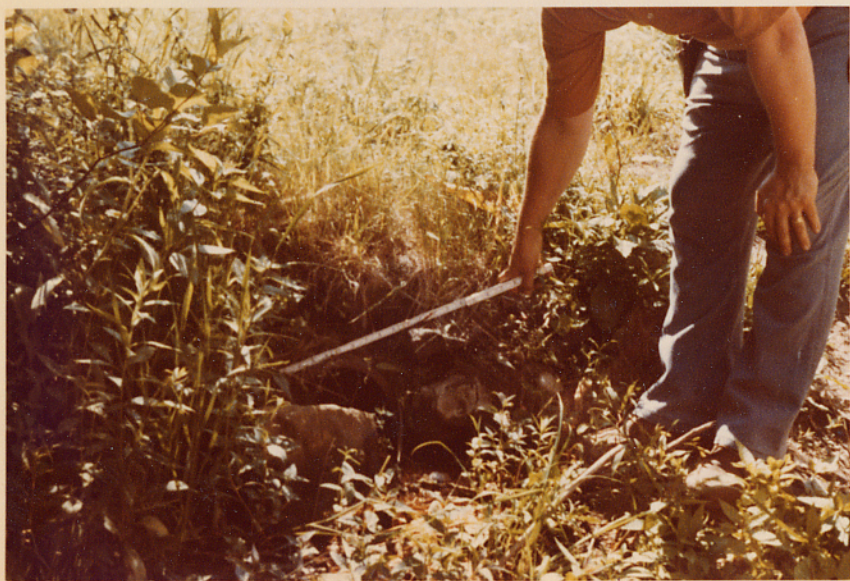
| 11 | Looking west toward toe-drain pipe near base of concrete section at the west bank of the downstream channel. Small discharge of water. Pipe is beneath the left end of the six-foot rule. |

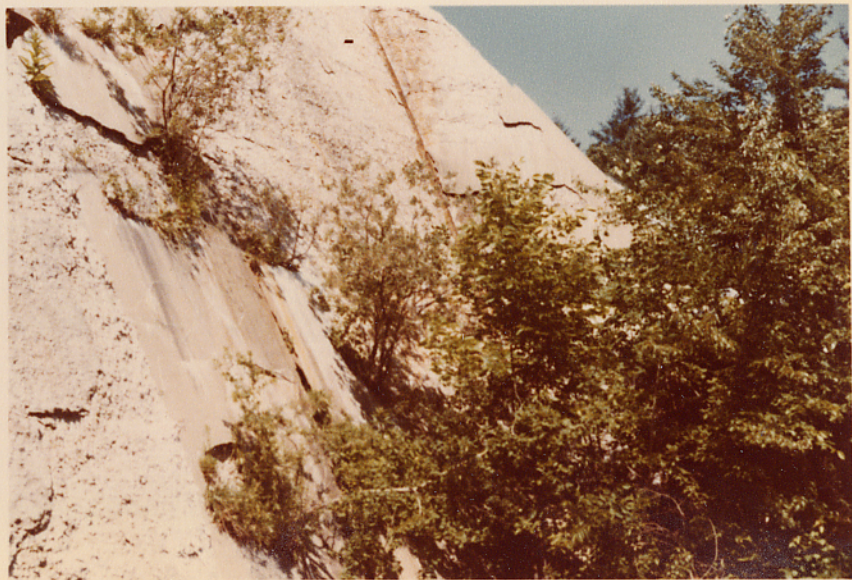
| 12 | Trees growing from deteriorated concrete in downstream face of concrete-gravity section between gatehouse and overflow spillway. Shown in background of photo 7. |
